Ingress/Egress Incidents Involving Wheelchair Users in a Fixed-Route Public Transit Environment

Karen L. Frost, Gina Bertocci, Sheryll Sison
University of Louisville

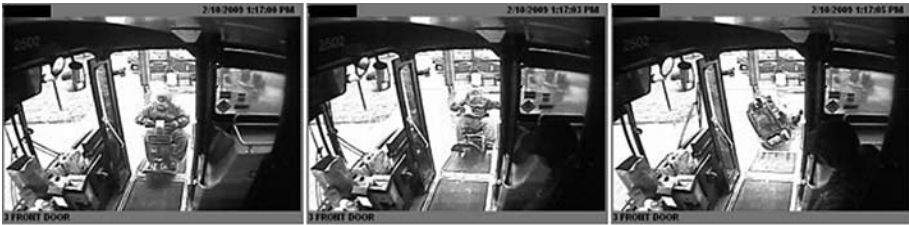
Ingress Events—Overview of Incidents and Difficulties, Time to Complete Ingress. Video recordings were examined to determine whether or not a difficulty or incident (as defined in Table 1) occurred during ingress. Of the 250 WhMD trips reviewed, one ingress event (0.4%) involved an incident and 38 ingress events (15.3%) were classified as involving difficulty, totaling 39 (15.6%) ingress incidents/difficulties. The single incident occurred during early afternoon, in light rain, and involved a male passenger who used a 3-wheeled scooter. The LATV was at a designated bus stop and the ramp was extended to a smooth concrete sidewalk. The scooter user approached the ramp using a forward-facing orientation and ascended the ramp to the point that the forward-most wheel crossed the interior vehicle threshold at the top of the ramp. Forward motion of the WhMD then stopped, and the passenger appeared to shift his body position slightly forward while toggling the controller with his right hand. The scooter and passenger then began to descend the ramp rearward. As the rear wheels contacted the exterior rubber threshold at the base of the ramp, the front wheel of the scooter began to rise upward off of the ramp surface. The scooter rotated rearward and toward the front of the vehicle, then fell to the sidewalk on its right side. The passenger fell rearward, landing on his buttocks and posterior torso (Figure 4). The passenger did not appear to be wearing a postural support lap belt. The passenger stated he was not injured and declined the LATV operator’s request to call an emergency medical service.

Figure 5. Video Footage of Ingress Incident

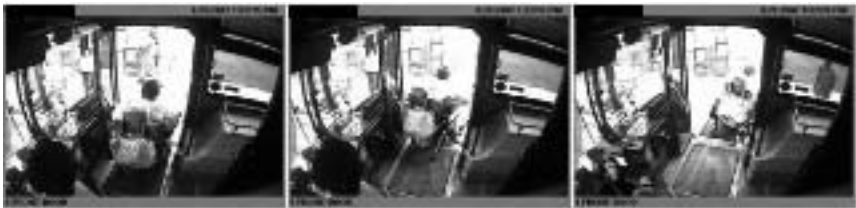
Egress Events—Overview of Incidents and Difficulties, Time to Complete Ingress. One incident and 11 difficulties were observed during egress. The single incident during egress occurred during early afternoon on a fair/dry day, and involved a female passenger who used a power wheelchair. Two canvas bags were looped around and behind the wheelchair headrest, and a purse was looped around the left armrest. The LATV stopped parallel to the designated bus stop and the ramp was deployed onto a smooth concrete sidewalk. The passenger's WhMD appeared to be properly aligned within the ramp edge barriers as the passenger approached the top of the ramp. However, as the front wheels crossed the interior vehicle threshold, the right front wheel began turning toward the right ramp edge barrier, and the rear casters began moving toward the left LATV doorframe. The passenger's forward motion continued, and the front right wheel drove over the ramp edge barrier. The WhMD pitched forward causing one rear caster to rise off the ramp surface (Figure 6). A passerby and the LATV operator provided immediate assistance. The passerby lifted the front of the WhMD and placed the front wheels back onto the ramp surface while the operator tilted the WhMD rearward. The LATV operator provided the passenger with verbal guidance to re-align her WhMD and assisted her down the ramp by holding the WhMD seatback canes until the passenger successfully exited the ramp. The WhMD-seated passenger was uninjured and remained seated in her WhMD throughout the incident.

Figure 6. Video Footage of Egress Incident

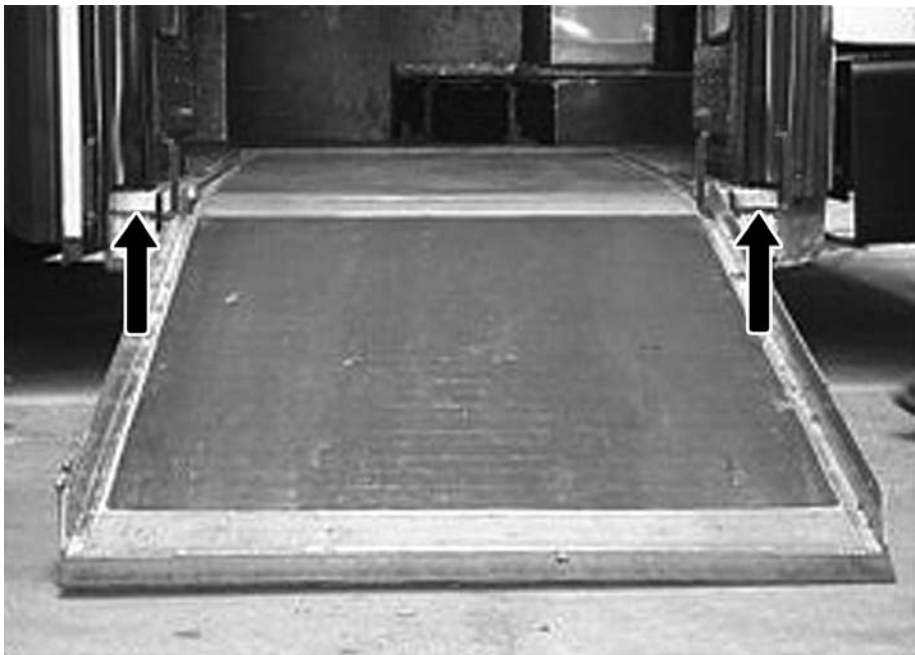
The majority of difficulties encountered by WhMD passengers during egress appeared to be related to issues involving a combination of ramp slope and narrow ramp width. Six videos revealed WhMD passengers impacting the ramp edge barriers; requiring them to reverse direction and/or re-align their wheels in order to descend the ramp successfully. Three events involved the front wheel of a power wheelchair becoming wedged in the gap between the LATV door and the ramp edge barrier (Figure 7). In four videos, the passenger turned the WhMD at the base of the ramp before the rear wheels cleared the ramp; in one of these videos, the LATV operator assisting the WhMD passenger turned the WhMD too early. In each of these four situations, the WhMD tilted laterally as a rear wheel drove over the ramp edge barrier. Only one of these difficulties appeared related to the surface terrain beyond the ramp.

Figure 7. Horizontal Gap between LATV Door and Ramp Edge Barrier

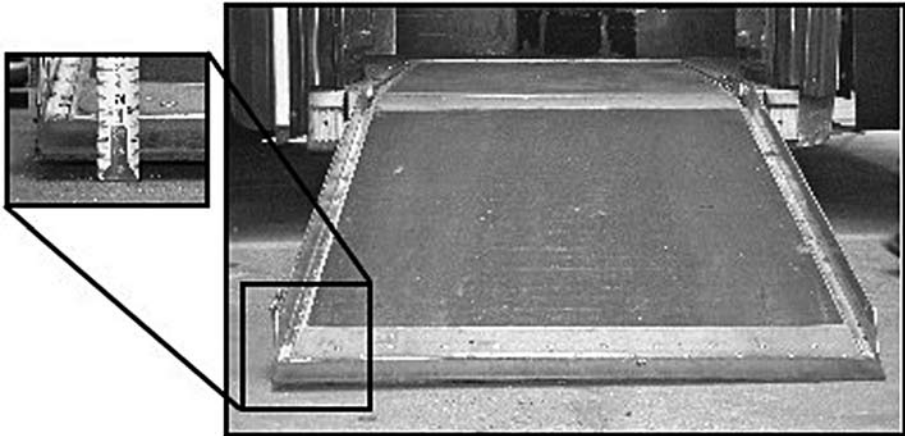
Uneven exterior ramp thresholds were also thought to be associated with difficulties during ingress. Exterior ramp thresholds were constructed of beveled rubber and met the ADA specification of a slope of 1:2. However, as shown in Figure 9, threshold warping from repeated usage and weathering could result in vertical gaps between the environmental surface terrain and exterior threshold. Additionally, uneven surface terrain and slight ramp surface cross slopes could contribute to vertical gaps at this interface. Some WhMD passengers had apparent difficulties navigating their WhMD over this vertical threshold gap. Such barriers to ingress

Figure 9. Exterior Ramp Threshold Showing Signs of Wear

could be addressed through the improved design of exterior thresholds providing a smooth transition between the ramp and environmental surface terrain.
