Safer Stops for Vulnerable Customers

Project Director:
Joel Volinski, Director
National Center for Transit Research

Principal Investigator:
Lisa E. Tucker, Research Associate

March 2003

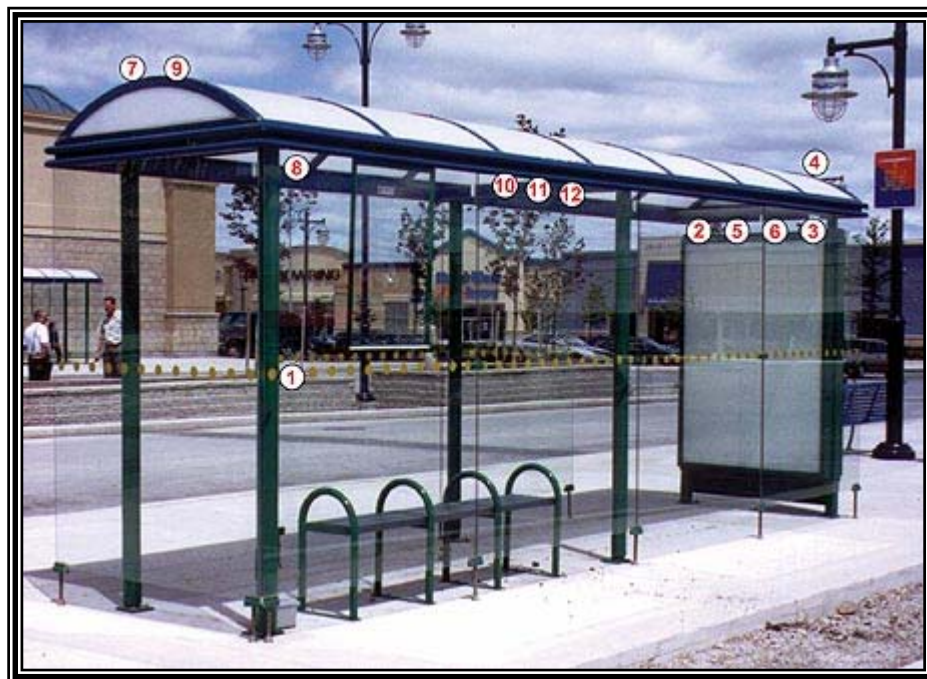
Figure 2: Features of the Smart Shelter (Daytech Manufacturing, Inc. website).

- schedule and special notices/changes display (10)—a monitor displays the schedule for the day as well as any special changes;
- audio annunciation (11)—voice informs passengers of when the bus will arrive in minutes and seconds; also tells of any special information or changes; and,

- map of approaching bus (12)—graphic display on the monitor of where the bus is on the route.

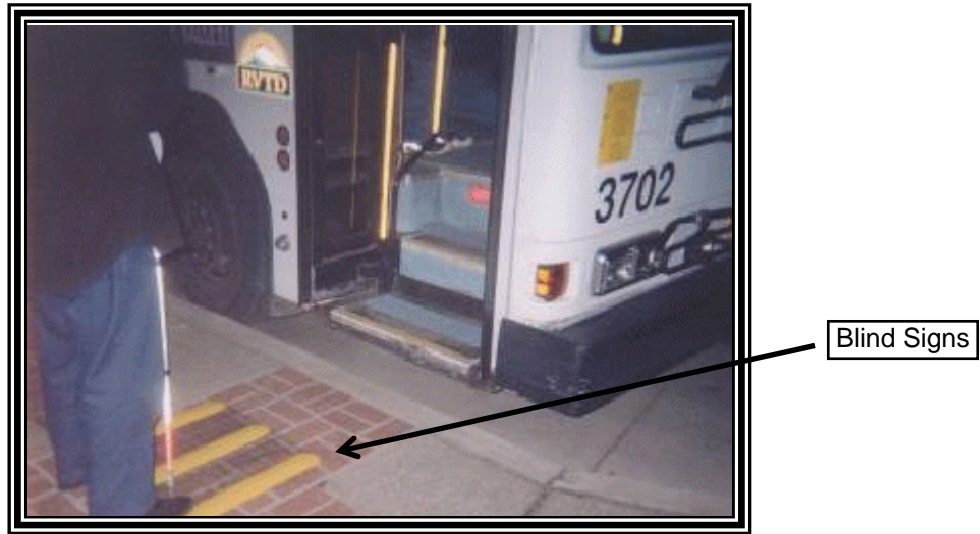
Figure 4: Three Yellow Blind Sign Strips Indicating Where to Board the Bus (Blind Signs, Inc. website).
